West Orange Library

Improvement Study _ 2015.12.08

3_ Findings Report

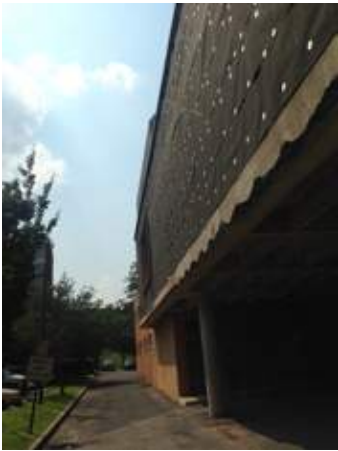
The most obvious issue to contend with is the brick façade failure at the 1978 addition. At the time of this writing the municipality had apparently contracted with a professional to design a replacement / repair of the façade. A new exterior cladding system of a thin-brick veneer or other lighter weight system is expected to be installed. The cost information shown on our matrix is derived from the apparent estimate of that project.

A1 _Brick facade replacement at 1978 addition

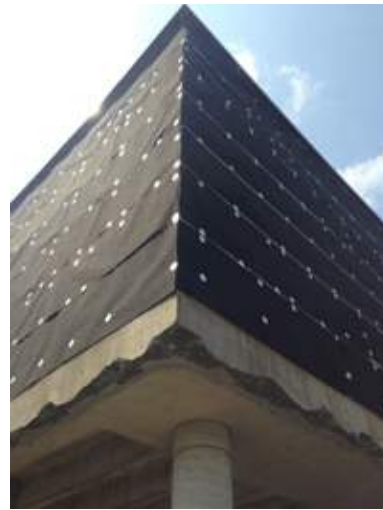
A2 _Brick facade replacement at 1978 addition

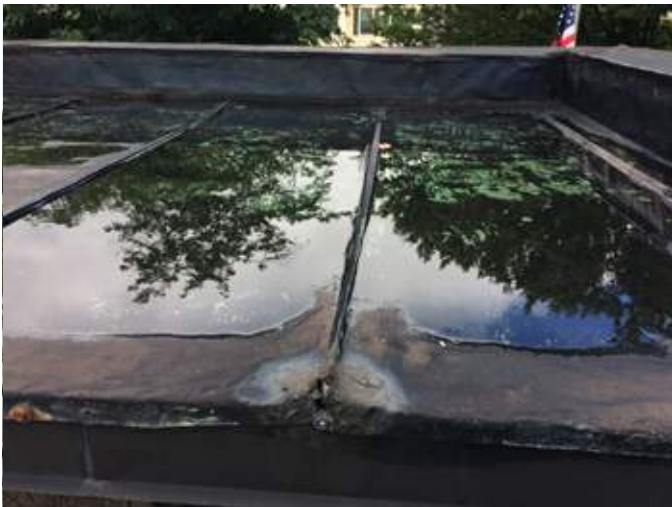
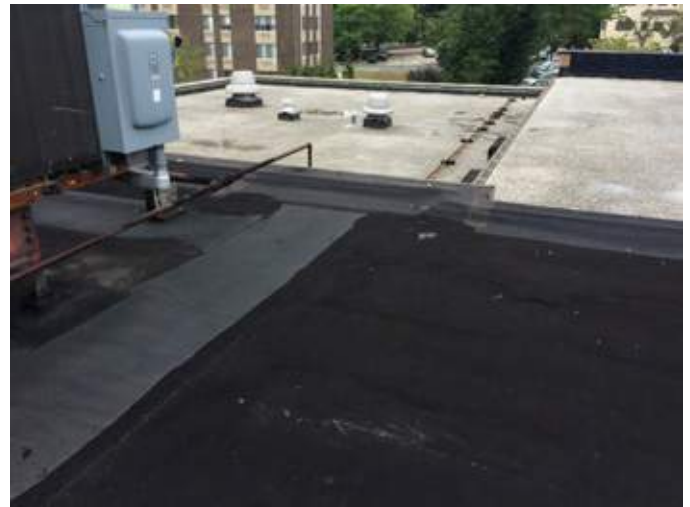
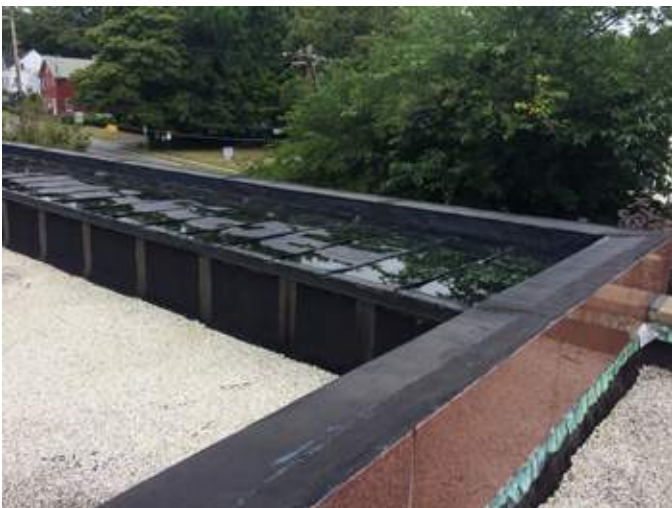
There was no record or anecdotal evidence that the original building roof area (approx. 8,500sf) had been replaced in recent years. It is likely that the roof of the original building requires replacement. When replacing a roof, the Code dictates that there can only be two layers of roofing due to the concern of weight. We would anticipate that the replacement of this ballasted roof would be removed and replaced with new. As well a portion of the original building has a standing seam roof system that has obvious damage. This section, located over the street entrance, is in need of replacement.

A3 _Roof replacement and new coping at original building

A4 _Roof replacement and new coping at original building

A5 _Roof replacement and new coping at original building

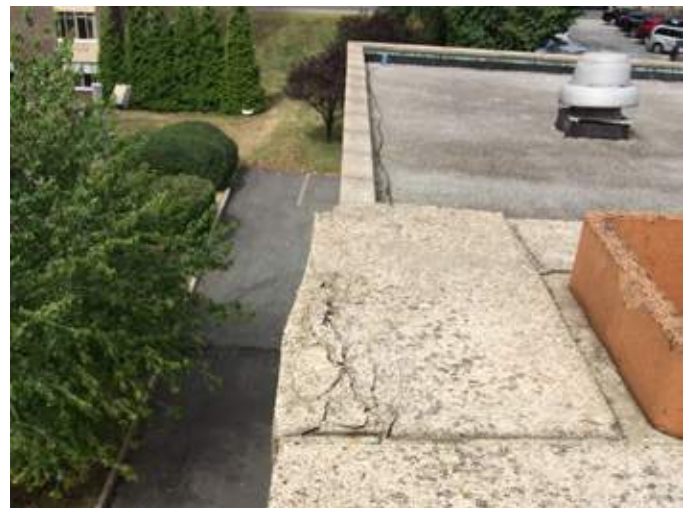
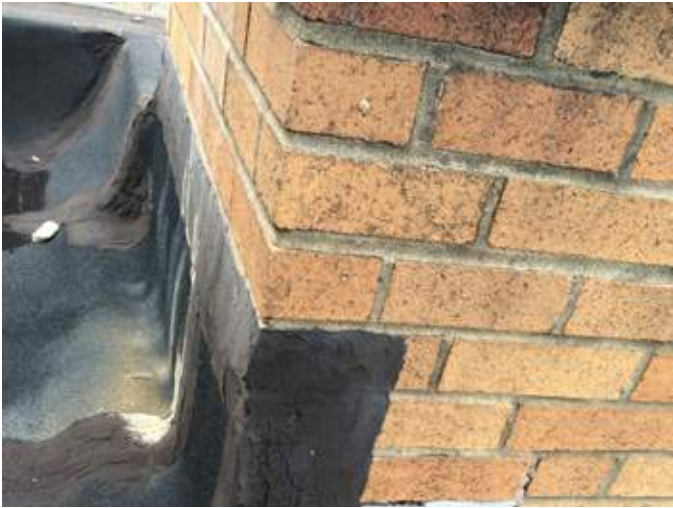
The chimney at the south wall, where the original and addition structures meet, is in need of repair. Its cap stone is cracked and the roof flashing at the base of the chimney has openings in need of repair. As well the trees that overhang the roof should be trimmed to minimize leaves which collect on the roof and can block drains.

A6 _Chimney cap stone replacement and flashing

A7 _Chimney cap stone replacement and flashing

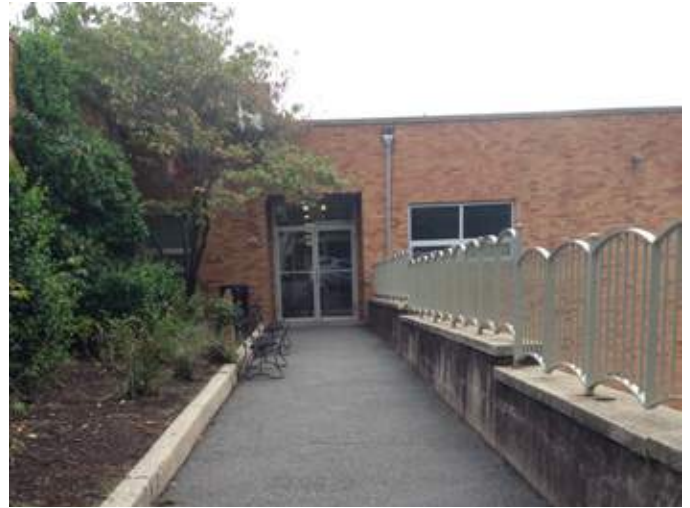
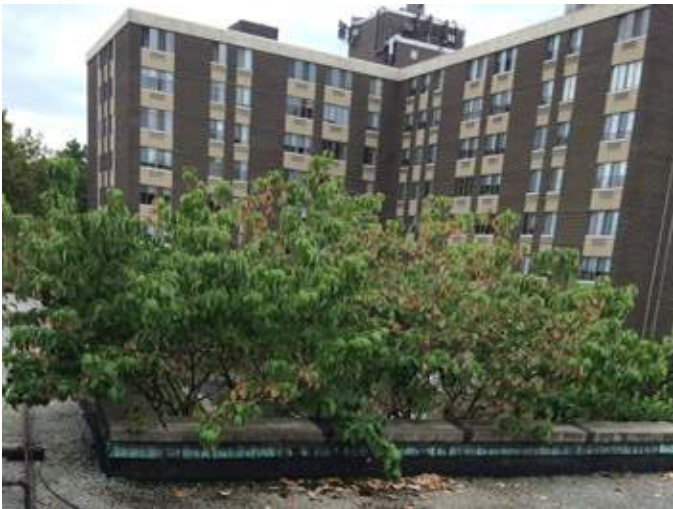
A8 _Trim trees overhanging the roof

A9 _Trim trees overhanging the roof

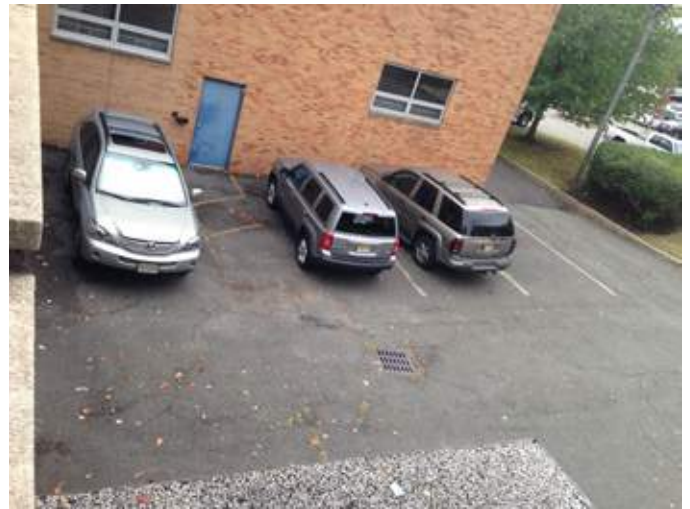
The windows and service doors appear to be in fair to good condition and can remain but the hollow metal service doors and frames require painting for protection. The main public entrance and vestibule doors appear to be original to the 1959 building and are in need of replacement. The entrance area and window wall along Mt. Pleasant Avenue has a painted soffit that requires repair or replacement. As well, new lighting should be installed at this soffit.

A10 _Exterior hollow metal door painting

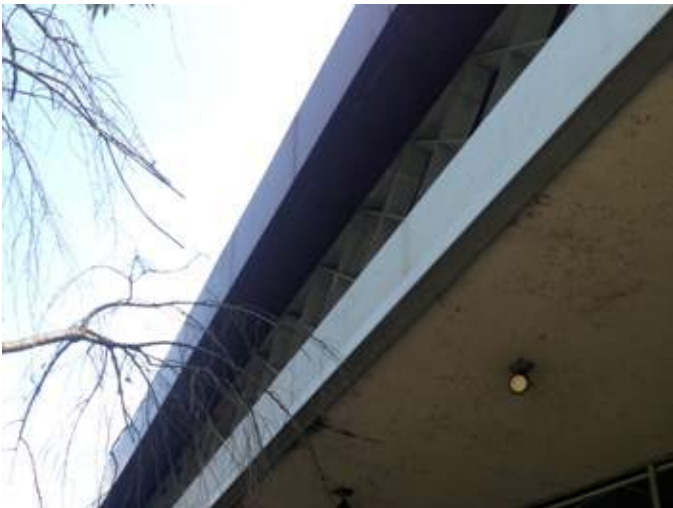
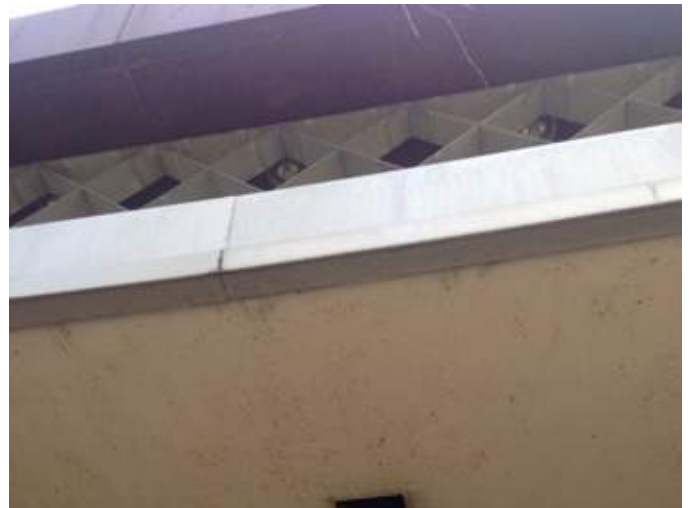
A11 _Replace Mt. Pleasant Ave. entrance area soffits and lighting

A12 _Replace Mt. Pleasant Ave. entrance area soffits and lighting

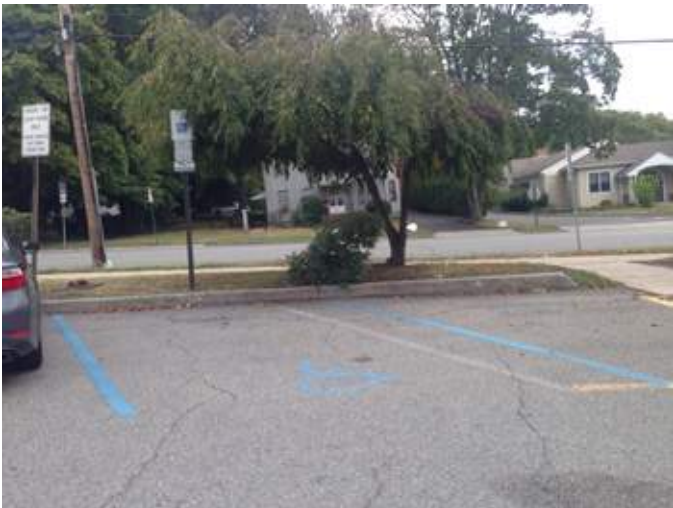
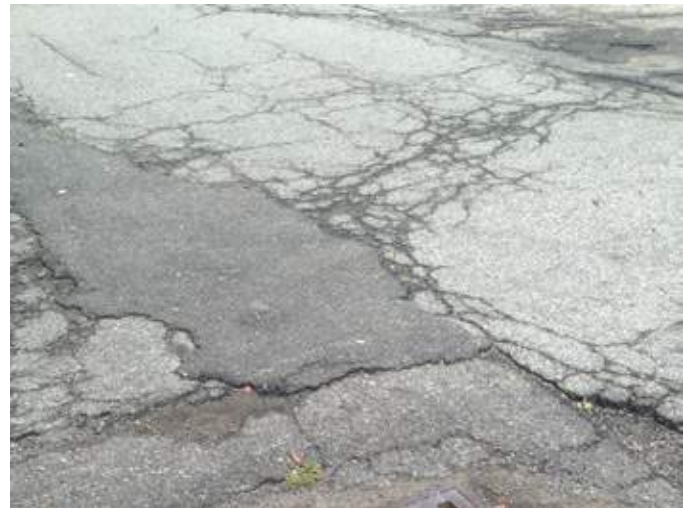
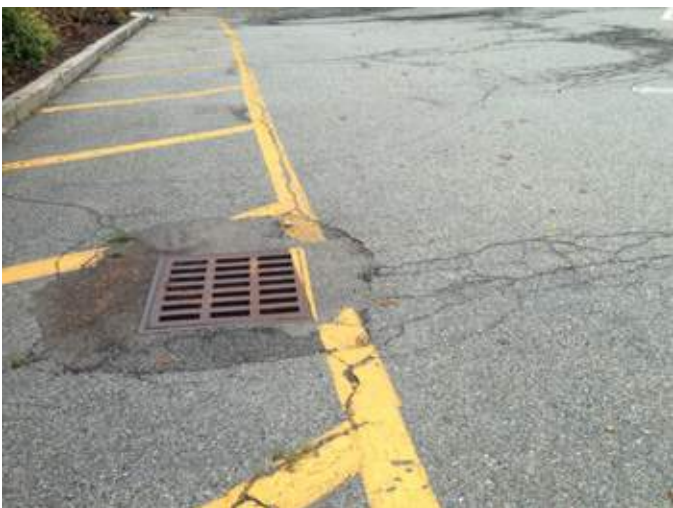
The parking lot along Gaston Street (approx. 11,400sf) serves the public and contains 32 spaces. This lot is in need of milling and a new top coat. The lot has numerous patches and surface deterioration. The parking space striping is faded and the assigned ADA/Barrier-Free parking spaces are improperly sized. The staff parking lot (approx. 4,600sf) has 9 spaces and is accessed via a driveway at the side of the building. The drive and the lot both require a seal coat to protect its condition and restriping afterwards. The parking area at the rear of the library is in good condition and is maintained by the municipality.

A13 _Gaston Street parking lot - mill and repave, restripe, proper ADA signs and layout

A14 _Gaston Street parking lot - mill and repave, restripe, proper ADA signs and layout

A15 _Gaston Street parking lot - mill and repave, restripe, proper ADA signs and layout

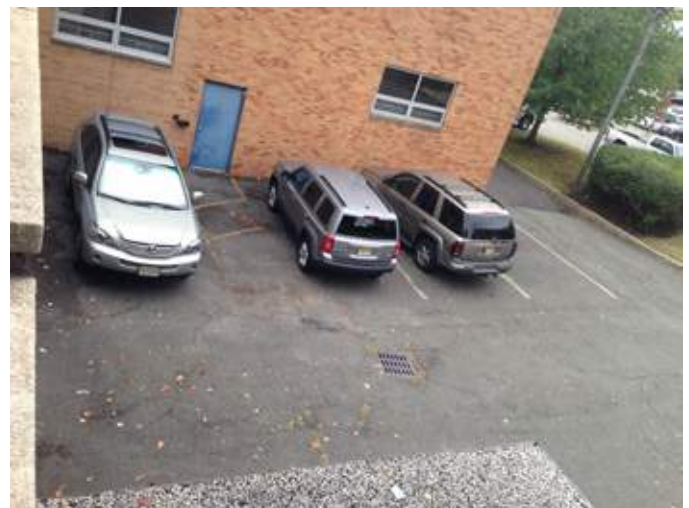
A16 _Side driveway and staff parking lot - seal coat and restripe

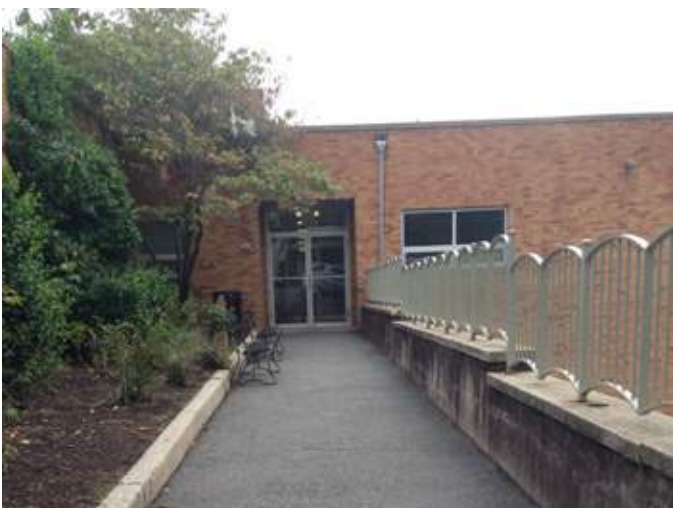
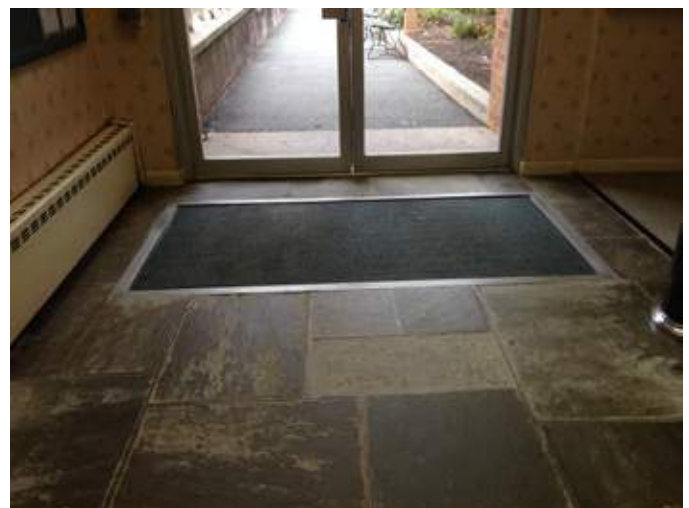
A17 _Replace entrance exterior and vestibule doors (4 pairs)

A18 _Replace entrance exterior and vestibule doors (4 pairs)

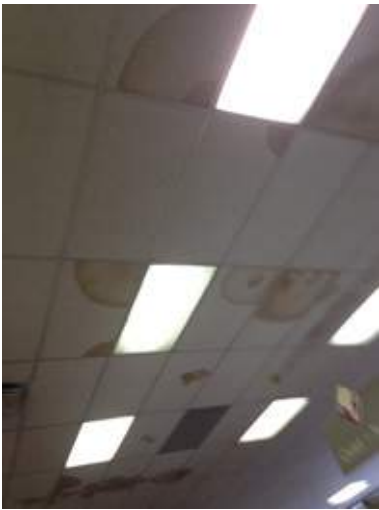
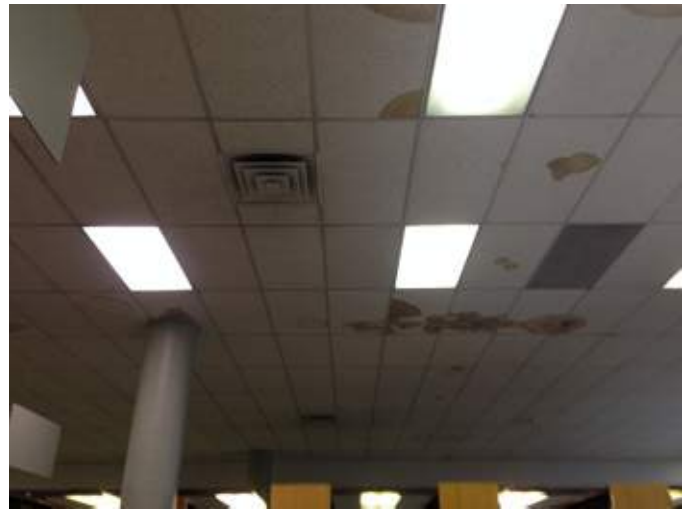
Overall, the upper level is in good condition. As of this writing the library is considering a rearrangement of furniture and book stacks in response to changing library services. Improved lighting levels, as noted in the engineer's report, and this new arrangement of furniture would improve the feel of the open public space. Throughout the Adult's Area the ceiling tiles are stained from former roof leaks and HVAC condensation issues. The entire ceiling of the Adult's Area, including the circulation desk zone, should be changed with new tiles. The suspension grid appears to be good condition and can remain.

A19 _Replace ceiling tiles at upper level adults area

A20_Replace ceiling tiles at upper level adults area

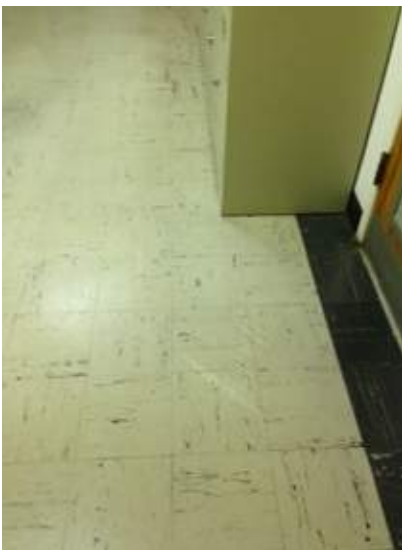
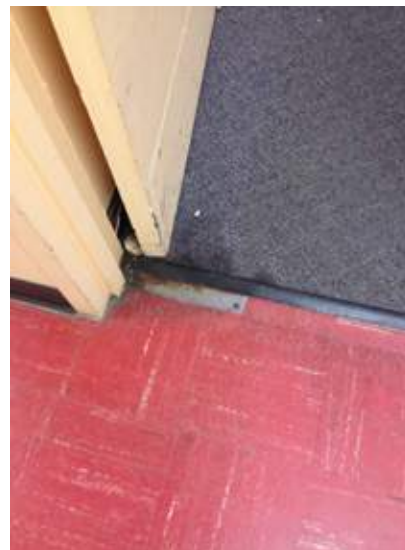
The book stacks and corridors have 9 inch floor tile which are potentially asbestos containing and should be tested given the age of the building. The ceilings throughout most of the lower level are comprised of 12 inch concealed spline tiles and are damaged in numerous areas. The lighting is very old and has missing lens covers and non-working fixtures. Walls throughout these areas are in need of patching, painting, and new wall base.

A21 _Test flooring tiles and replace/cover at lower level storage/stack area

A22_Test flooring tiles and replace/cover at lower level storage/stack area

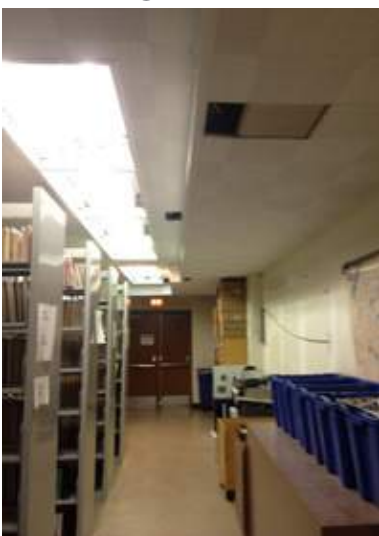
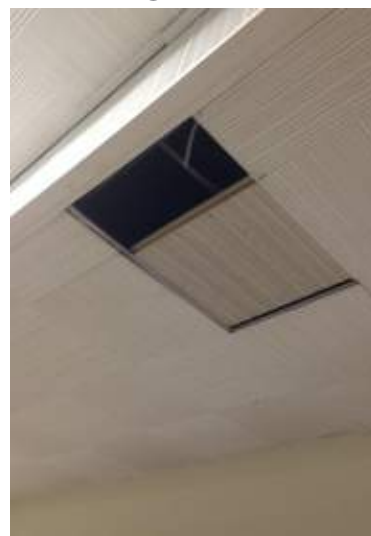
A23_Replace ceiling at lower level storage/stack area

A24_Replace ceiling at lower level storage/stack area

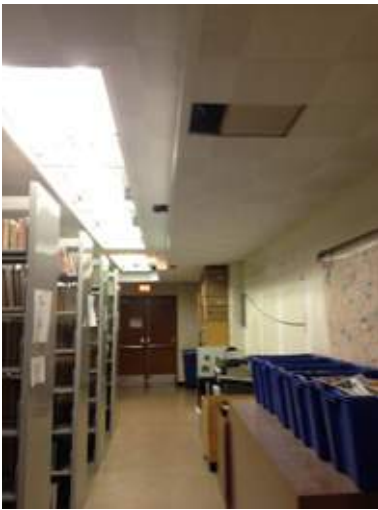
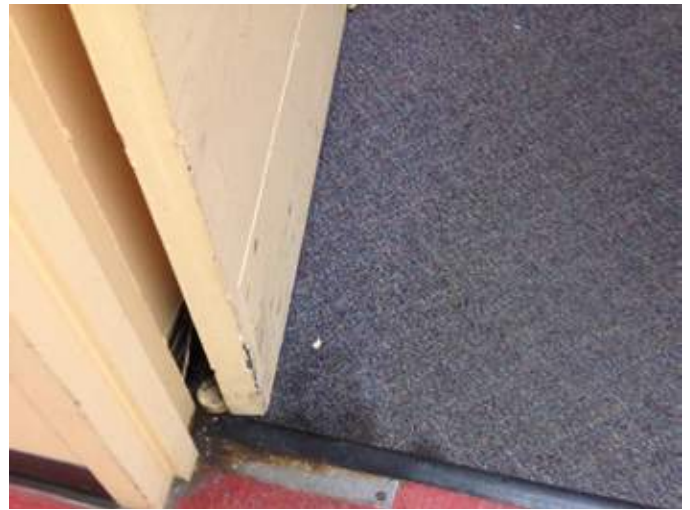
A25 _Paint walls and replace wall base at lower level storage/stack area

A26 _Paint walls and replace wall base at lower level storage/stack area

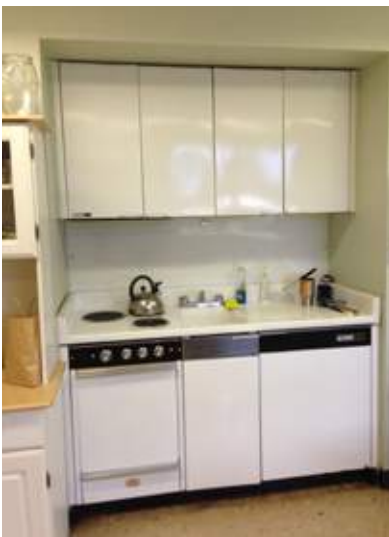
The staff lounge contains an original 'Dwyer' unit kitchen which is in need of replacement. A new counter, sink and refrigerator are necessary. The restrooms at the lower level are dated and in need of new fixtures for water conservation and general functionality. If the upper level public restrooms are made to be Barrier-Free then these rooms would only need to comply with the Code in as much as is readily achievable since there is an elevator and those rooms are only 1 floor above. Thus, any new fixtures, accessories, and modification should conform where possible.

A27 _New kitchen counter, sink and appliances

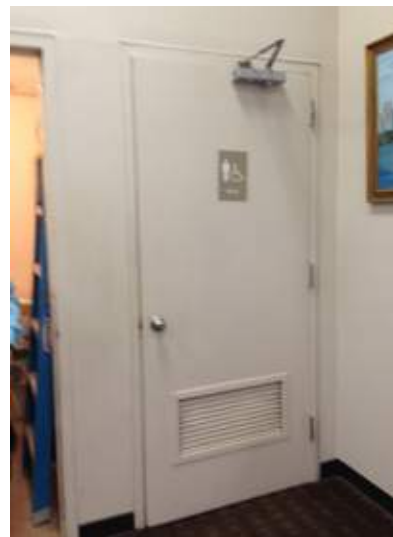
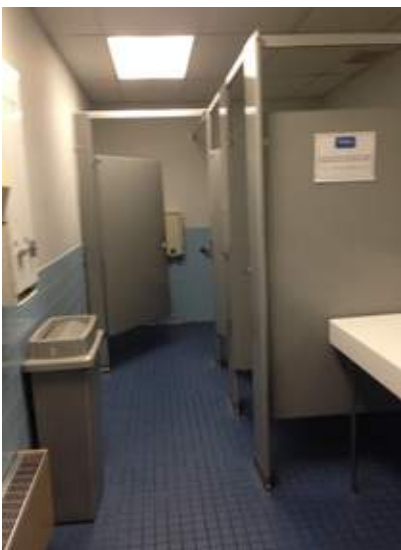
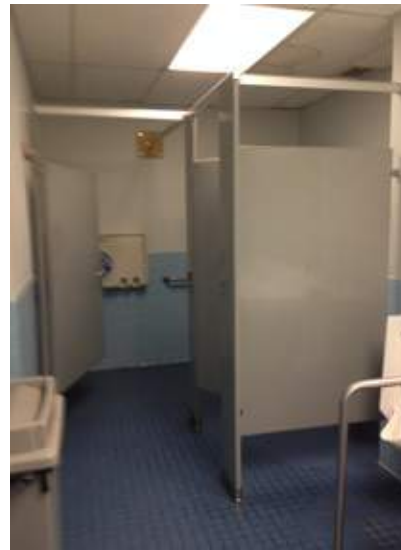
A28 _Modify public restrooms for ADA compliance

A29 _Modify public restrooms for ADA compliance

A30 _Modify public restrooms for ADA compliance

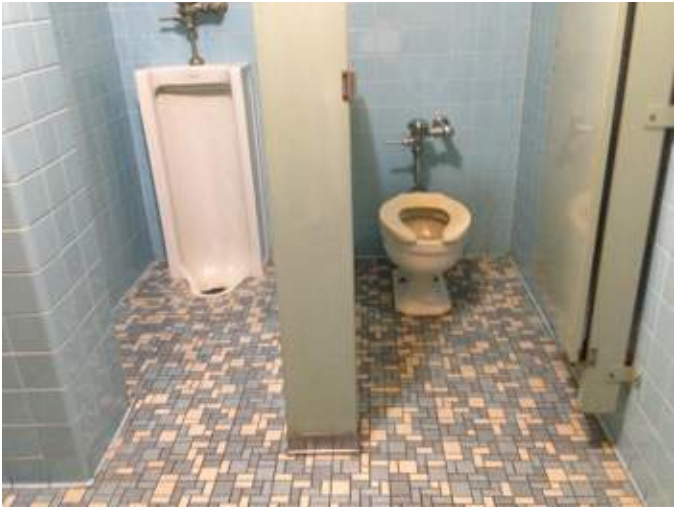
A31_ New plumbing fixtures and accessories at all other restrooms

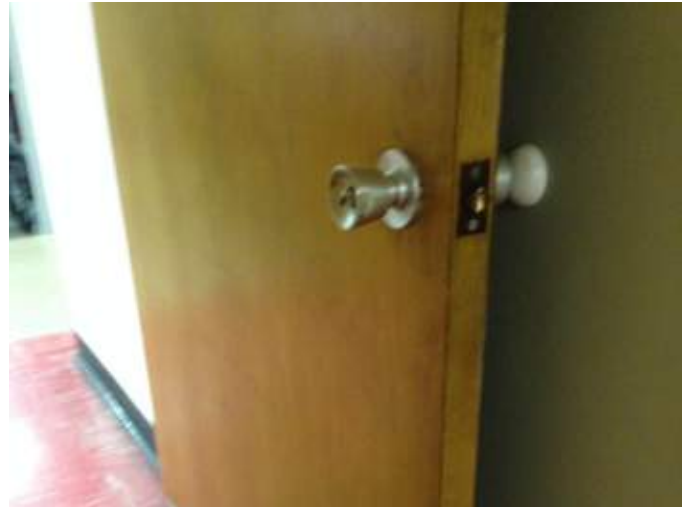
Access to goods and services is provided by having proper aisle space, door maneuvering clearances, and proper door hardware. The library meets these criteria throughout most of the spaces. The aisles and maneuverability through fixed furniture appears acceptable but there are a number of doors that have knobs instead of levers. Levers are required since a twisting motion is difficult for persons with disabilities.

A32 _Replace door knobs with lever handles

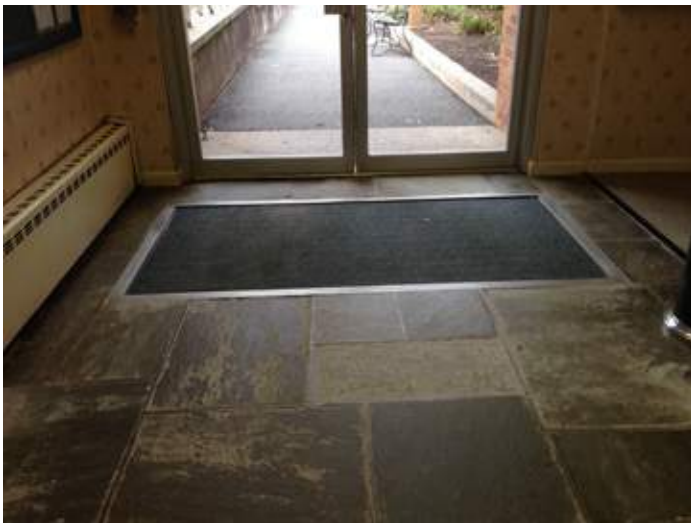
As you enter the upper level, the entrance lobbies both have a walk-off mat set in a recessed pocket to catch snow and debris from shoes. These mats were replaced with a thin carpet that exposes the edge of the pocket. This edge is about 5/8 inch tall and poses a tripping hazard and is non-compliant with the ADA. A new mat of sufficient thickness should be installed to minimize the exposed edge.

Approaching the building from this parking lot and other walkways is generally accessible. The original building entrances both appear to be compliant but the Mt. Pleasant Avenue street sidewalk is sloped due to the natural topography. As noted earlier, the walk-off mats are to be replaced to eliminate the exposed edge of the recessed pocket which poses a tripping hazard and is not compliant with the ADA.

A33 _Tripping hazard and ADA issue at entrance
walk-off mat pockets-replace mats

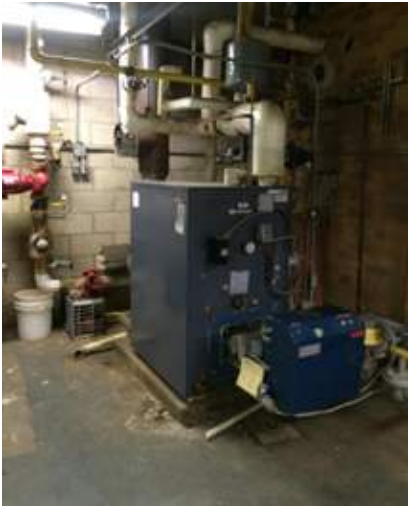
E1_Existing Boiler in Basement

The hot water boiler and pumping system appear to be in good condition. The boiler is serviced once a year by Mike Boan, who starts the boiler and the four zone pumps in October. In the spring, the Library's maintenance person shuts them off. It appears that no one knows where the control valves are located, or if any of the existing controls are working. It is recommended that a new automatic temperature control and building automation system be installed to control both the hot water heating system and the proposed new rooftop units.

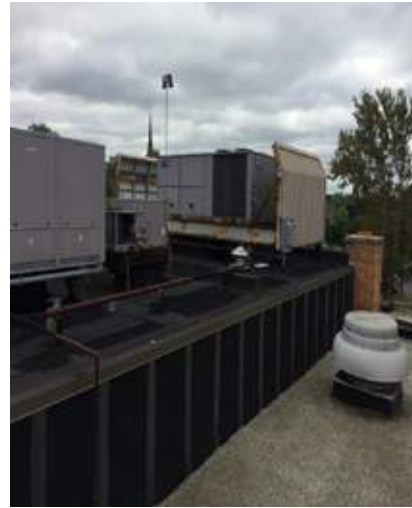
E2_RTU's on Roof

In 1978, four Carrier gas-fired heating/electric DX cooling package rooftop units were installed to replace the two split systems. In 2002, a 15 horsepower gas-fired boiler was installed to serve the existing perimeter fin tube radiation. RTU-1 is a 40 ton unit that serves both floors of the original building, except the Children's Area. RTU-2 is a 5-ton unit that serves the large meeting room in the 1978 addition. RTU-3 is a 30-ton unit that serves the rest of the 1978 addition. RTU-4 is a 7.5-ton unit that serves the Children's Area.

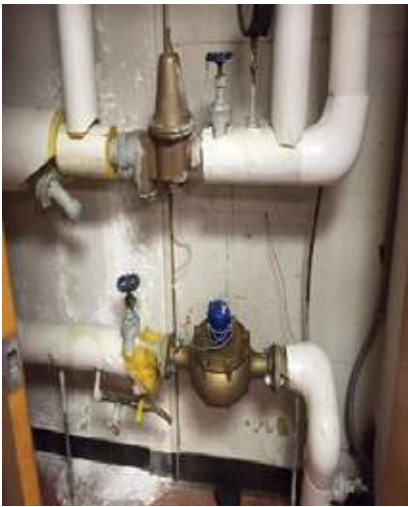
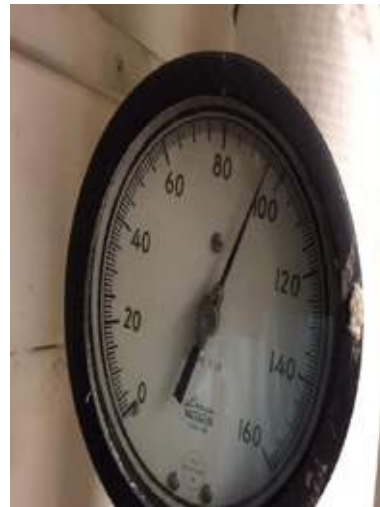
The domestic water service seems to be in good working order; however the pressure of reading of 95 PSI is of some concern. We would recommend testing the water pressure to determine the gauge is working correctly, and if found to be working correctly to test the pressure reducing valve, (PRV) to ensure it is set properly. If all is working correctly we would recommend replacing the PRV with one that sets the water pressure to 65 PSI.

E3_Water Service , Meter and PRV

E4_Water Pressure Gauge

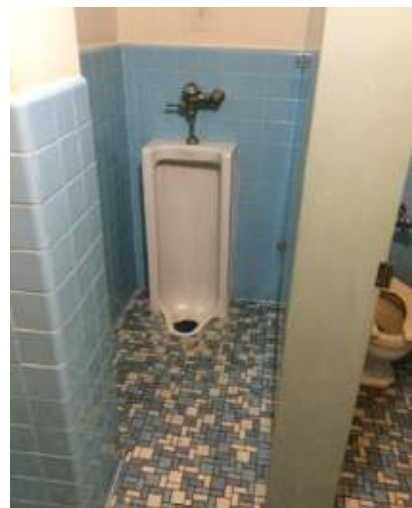
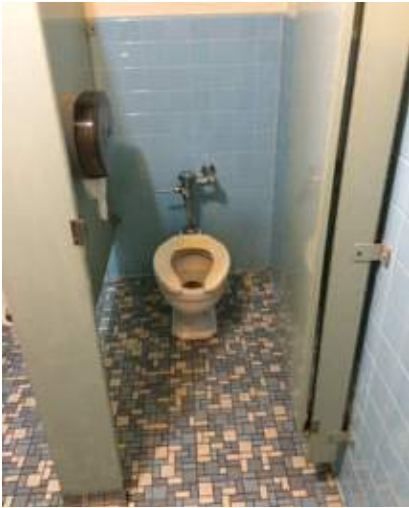
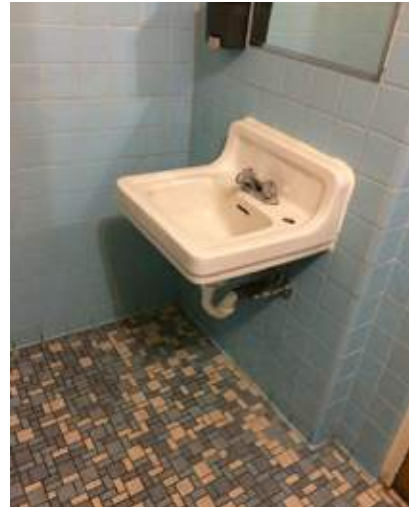
The existing toilet room fixtures do not meet ADA. The height of the fixtures, specifically the water closets. It appears that some have been replaced. Any upgrades within the toilet rooms could potentially trigger fixture replacements. All new fixtures would be required to meet ADA. Also, new fixtures use less water which would result in a certain level of water conservation.

E6_Typical Urinal

E7 _Typical Water Closet

E8 _Typical Lavatory

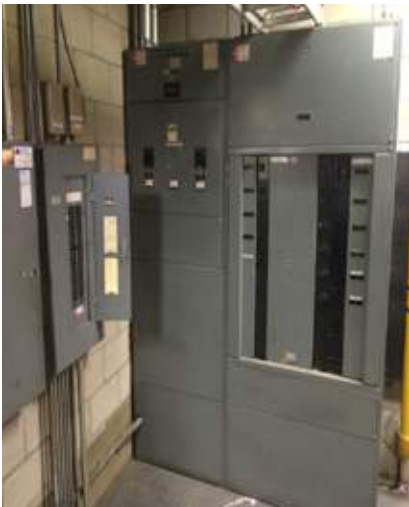
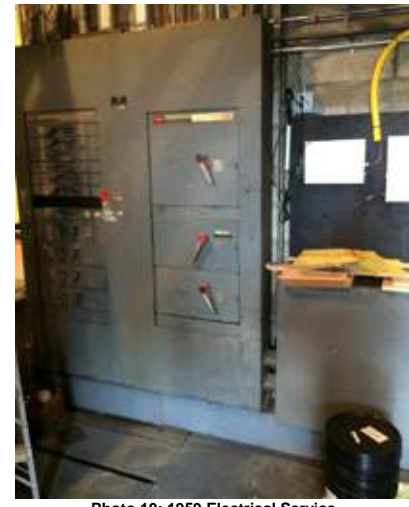
Though the equipment is relatively old especially the 1959 electrical equipment, there have been no reported issues with it. However, there comes a point when replacement parts become unavailable and the equipment itself becomes obsolete. We would recommend replacement of the 1959 600amp switch board with new circuit breaker type panel.

E9 _Building Service Switchboard-1978

E10 _Electrical Service-1959

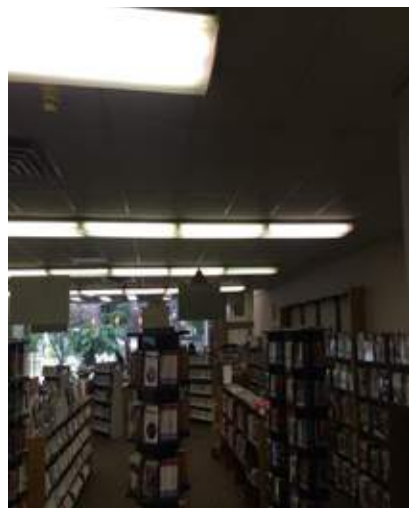
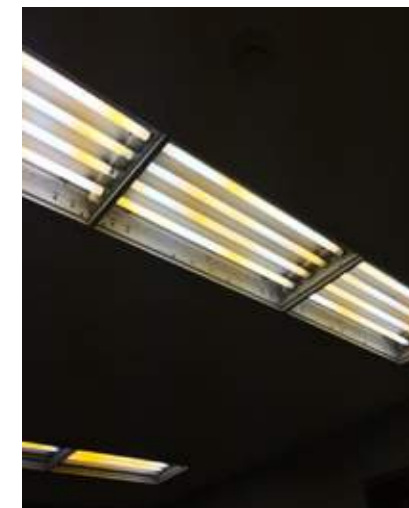
We would recommend a plan to replace or retrofit all the lighting fixtures throughout the library with new LED driven fixtures. The energy use can be estimated to be halved as compared to the existing fluorescents. The energy saving could be significant. PSE&G offers rebates, through the Smart Start Program, to customers replacing old units with higher efficiency units.

E11 _Main Area Lighting

E12 _Back of House Lighting
